Manhole Inspection Summary

Manhole # S13OO1019MH

Insp Date: **11/29/06 8:32 AM**

Location Address: **2911 WOODLAND AVE**

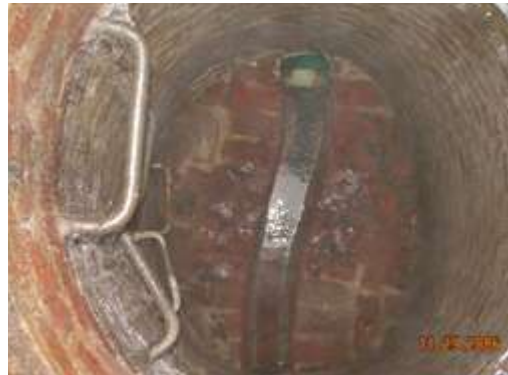
Top View

Barrel infiltration. Corroded steps. Bench debris.

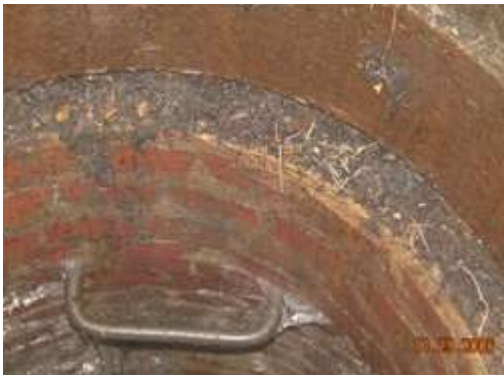
Defect

Offset: **2** (in.)

Condition: ☐ Sound ☐ Cracked ☒ **Leaks**

Infiltration: ☐ None ☒ **Joint** ☐ Cracks ☒ **Mortar** ☐ Roots ☐ Wall

Frame leaks. Frame offset. Adjustment infiltration.

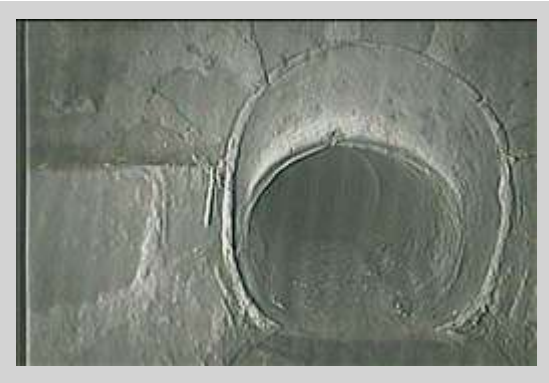
8 in. Circular Gravity Sewer Pipe Out @ 12 O'Clock

Pipe Material: **Clay** ☒ Pipe Lined

Infiltration: **None** Pipe Seal Cond: **Unknown**

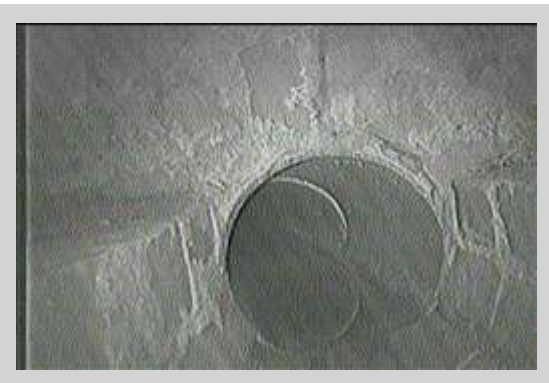
8 in. Circular Gravity Sewer Pipe In @ 6 O'Clock

Infiltration: **Evidence** Pipe Seal Cond: **Cracked**
